Final Study Report

JOINT OBSERVATIONAL STUDY (JOS)

Seaway Shoreline Icebreaking Impacts Between Snell Lock & Lake St-Francis

August 2009 – Final Version

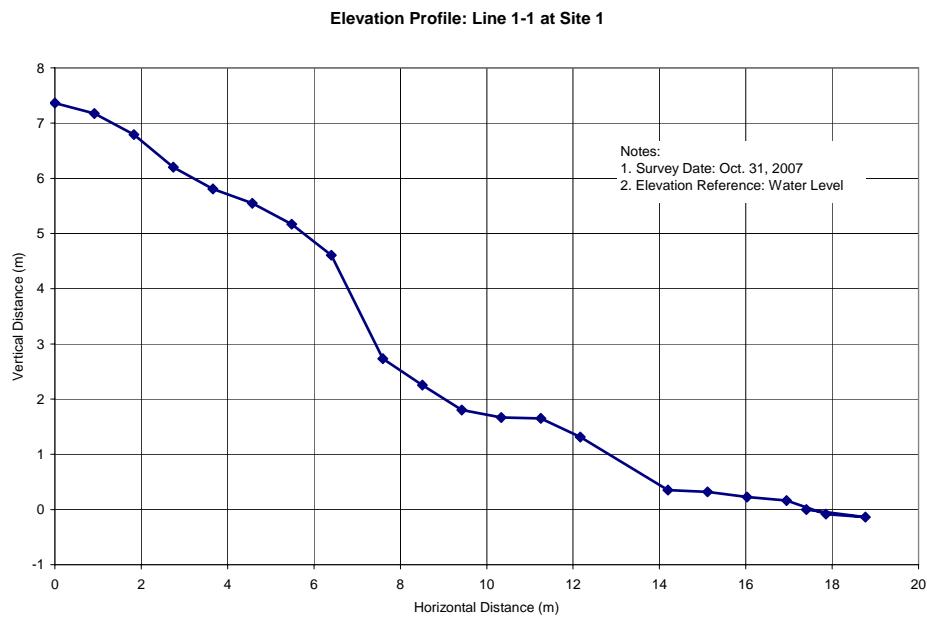
Figure 4.2a Elevation Profile Measurement Approach A

Nevertheless, no major shoreline changes were visually identifiable at each of the three (3) surveyed sites. No evidence of ice-induced shoreline damage, such as berms, ridges or scars were observed. Although variations in elevations were noted at several sites, these were considered well within the resolution of the survey technique and consequently not indicative of any slope movement.

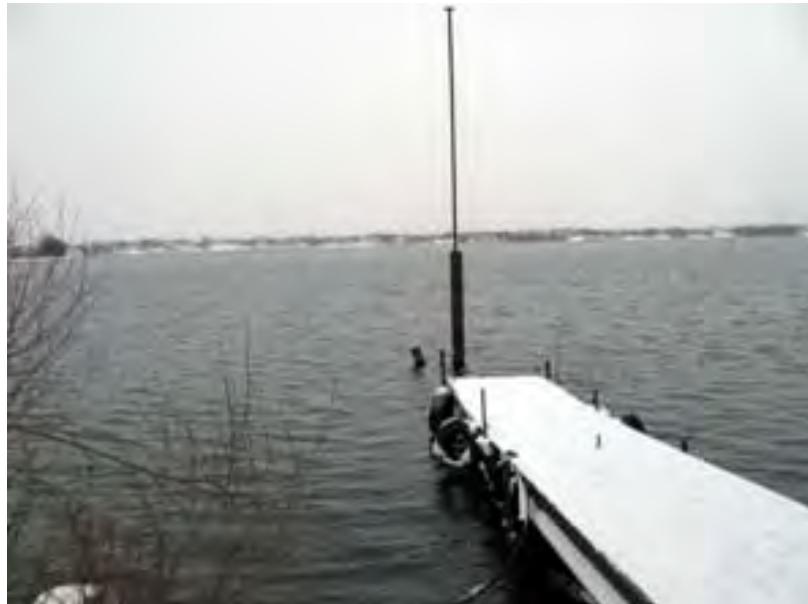
Figure 4.3 Dock Selected for Location Surveys

The objective of this type of survey was to measure the movement of the ice cover near the shore by monitoring changes in the position of a strategically located structure such as a wharf that was left in the water over the winter. **Figure 4.3** shows the selected dock located on the south side of **Cornwall Island**. The task required precise monitoring of the readily accessible anchoring posts. The baseline position of each post was carefully measured in the fall of **2007**. Unfortunately, access to the dock was denied by the landowner in the following spring and consequently, the planned spring observations could not be completed to verify if movement occurred.

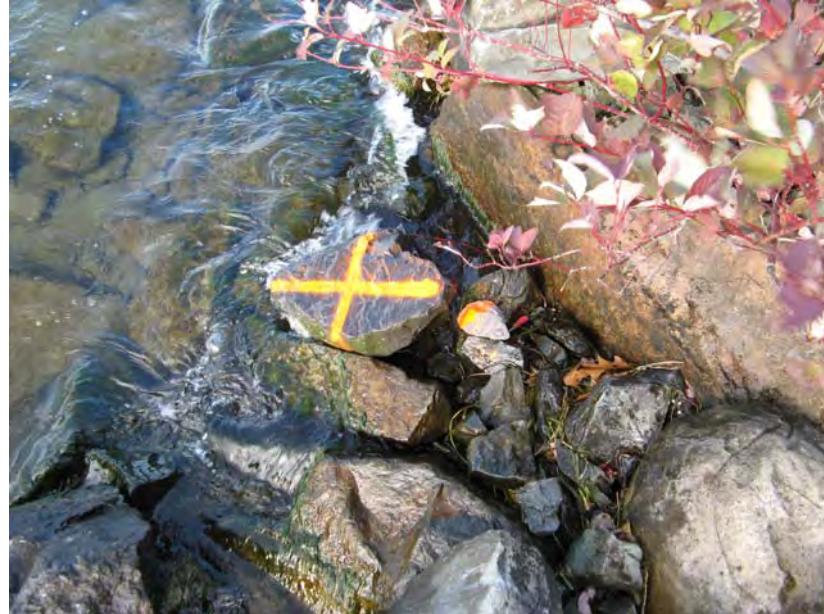
Figure 4.4 Typical Marking of Rip-Rap Stone

changes in their location in the spring. **Figure 4.4** shows a typically marked (fluorescent spray paint) rip-rap stone during the first year the survey was completed.

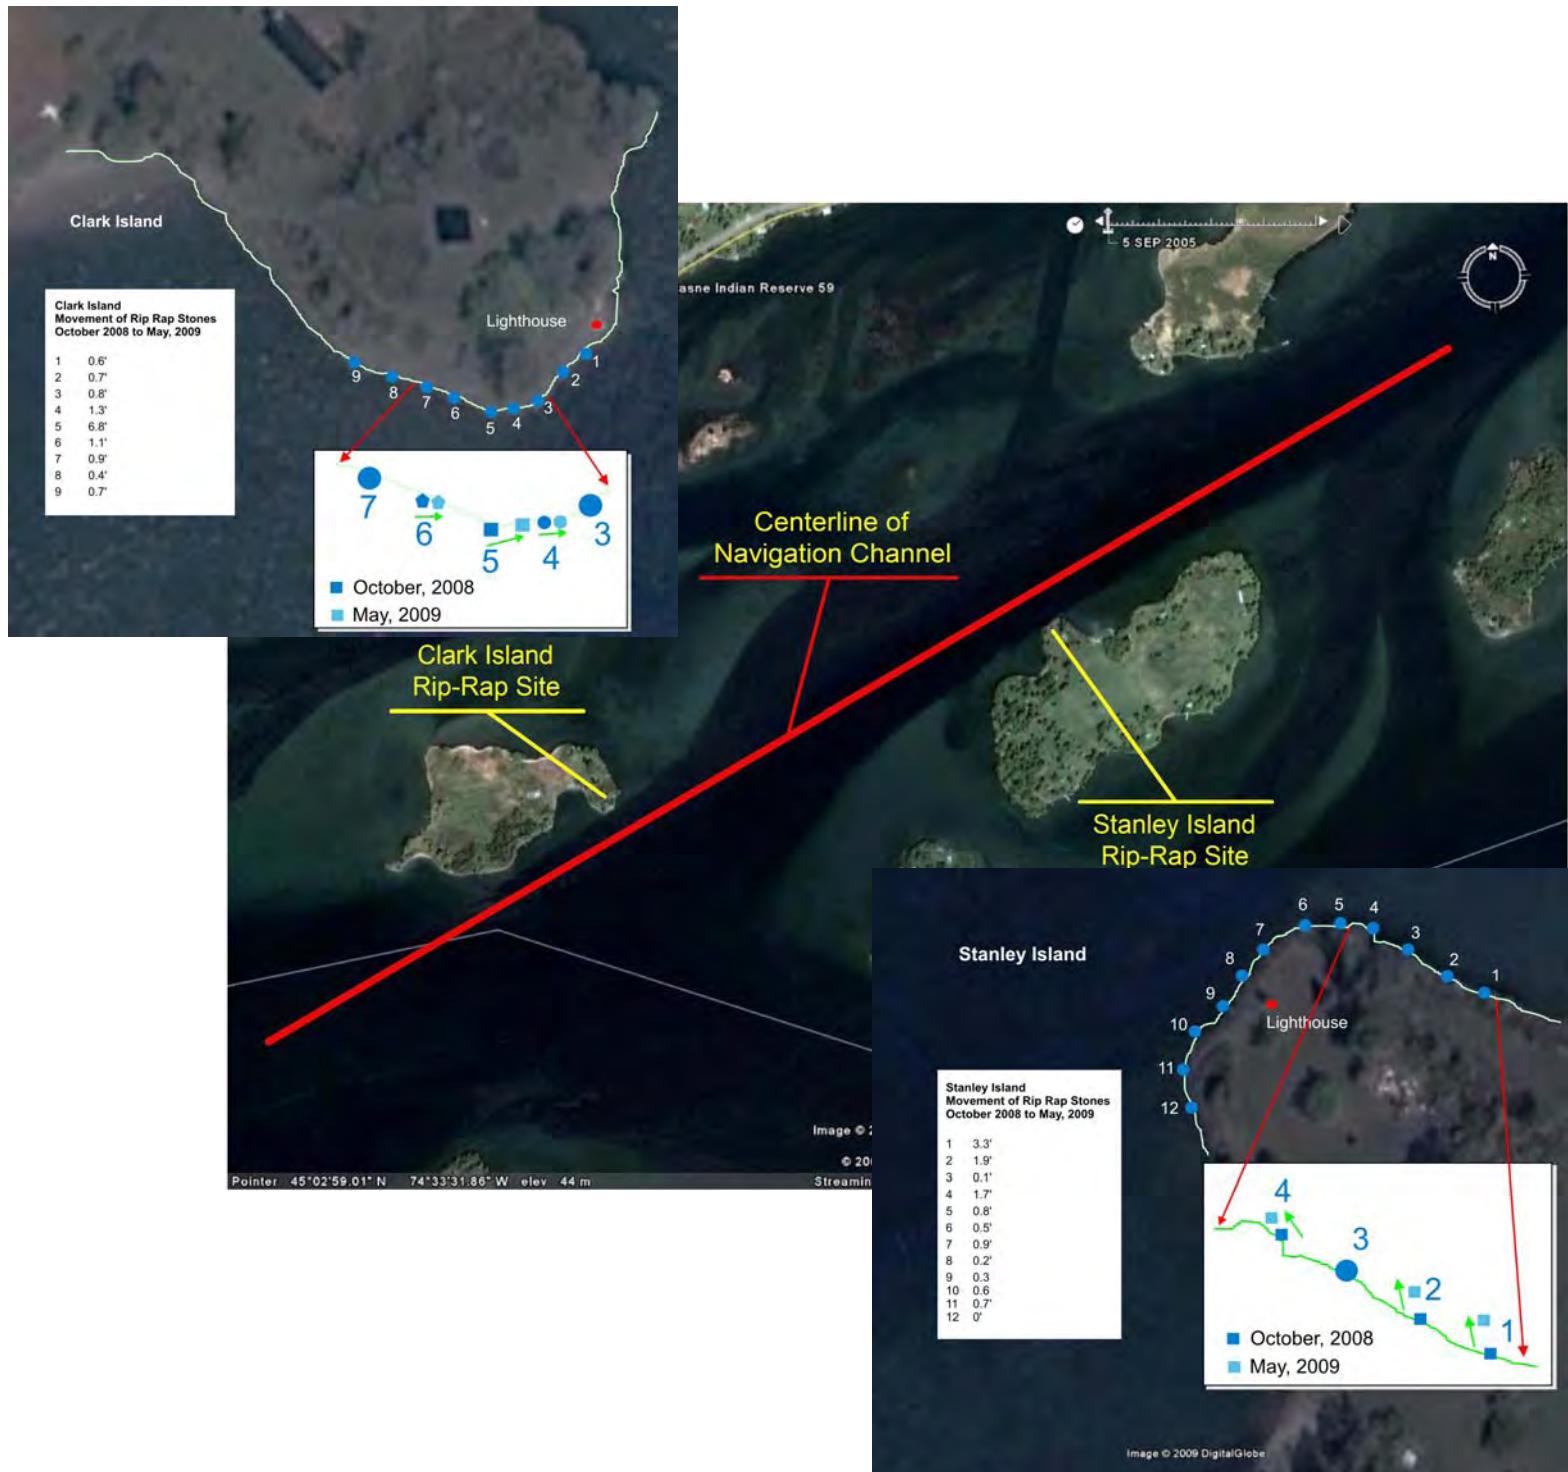
Figure 4.5 Locations of Rip-Rap Survey Sites & Stones – 2008/2009
(Background imagery from Google Earth)

Figure 4.5 shows the location of the two (2) surveyed sites while the insets show the precise location of each rip-rap stones at each of the two sites (blue dot) during the **2008/2009** season. Only the **Stanley Island** site was surveyed in **2007/2008**.

The selected rip-rap stones were relatively small compared to most of the rocks along the shore of the two (2) sites. This was done deliberately so that the survey would generate conservative results, in that the selected stones were more likely to be moved than most of the ones along the shoreline. It should be further noted that the survey was focused on observing or measuring large-scale movements. Consequently, high precision survey methods were not considered to be necessary. Triangulation to fixed reference points was used to position each stone. Eight (8) stones were marked in the **2007/2008** season, along the shore at **Stanley Island** while twenty-one (21) stones were tagged during the **2008/2009** season, along shorelines near the shipping channel at **Clark** and **Stanley Islands**.

The surveys were successful in detecting movement on each of the two (2) years of measurements. Two (2) out of eight (8) stones showed significant movement during the 2007/2008 season while six (6) stones out twenty-one (21) moved 0.3 m or more during the 2008/2009 season (see **Figure 4.5** insets). During the **2007/2008** season, the largest measured movement was 1.6 m. The study team noticed that in most cases the stones shifted off-shore but remained in the same attitude (i.e. did not roll over). The observed stone movements also appeared to be localized as large-scale changes to the shoreline rip-rap were not observed.

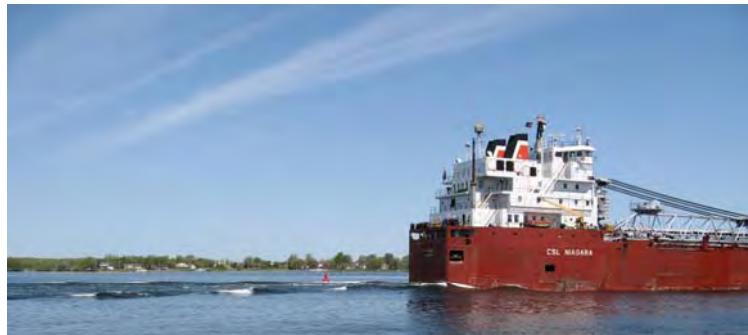
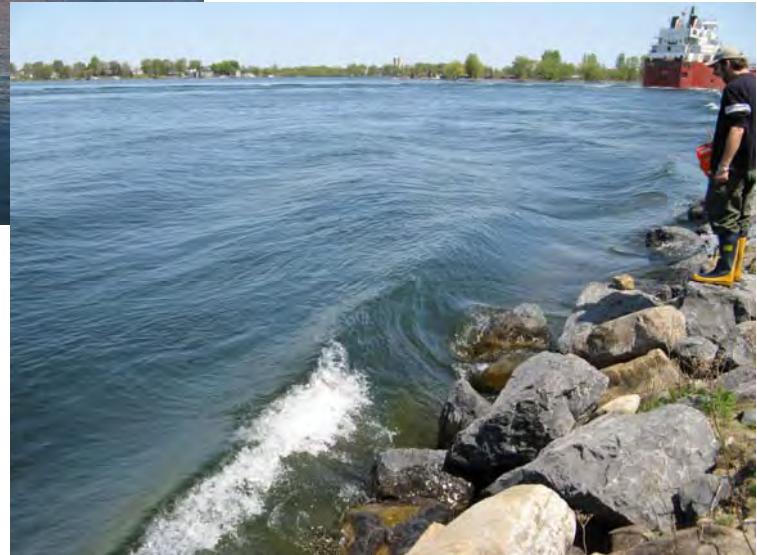
Figure 4.6 Ship Generated Waves (Stanley Island Site May 14, 2008)

A number of possible explanations for the rip-rap stone movements were elaborated following the **2007/2008** season. It was eventually concluded that ship-induced currents and waves were the most plausible causative factor. Several ship passages were observed during the two (2) spring surveys that generated waves of approximately 0.3 m in height (see **Figure 4.6**) with accompanying local surges and draw-downs in the mean shoreline water level. Noticeable currents were also produced along the shoreline by these local surges and draw-downs.

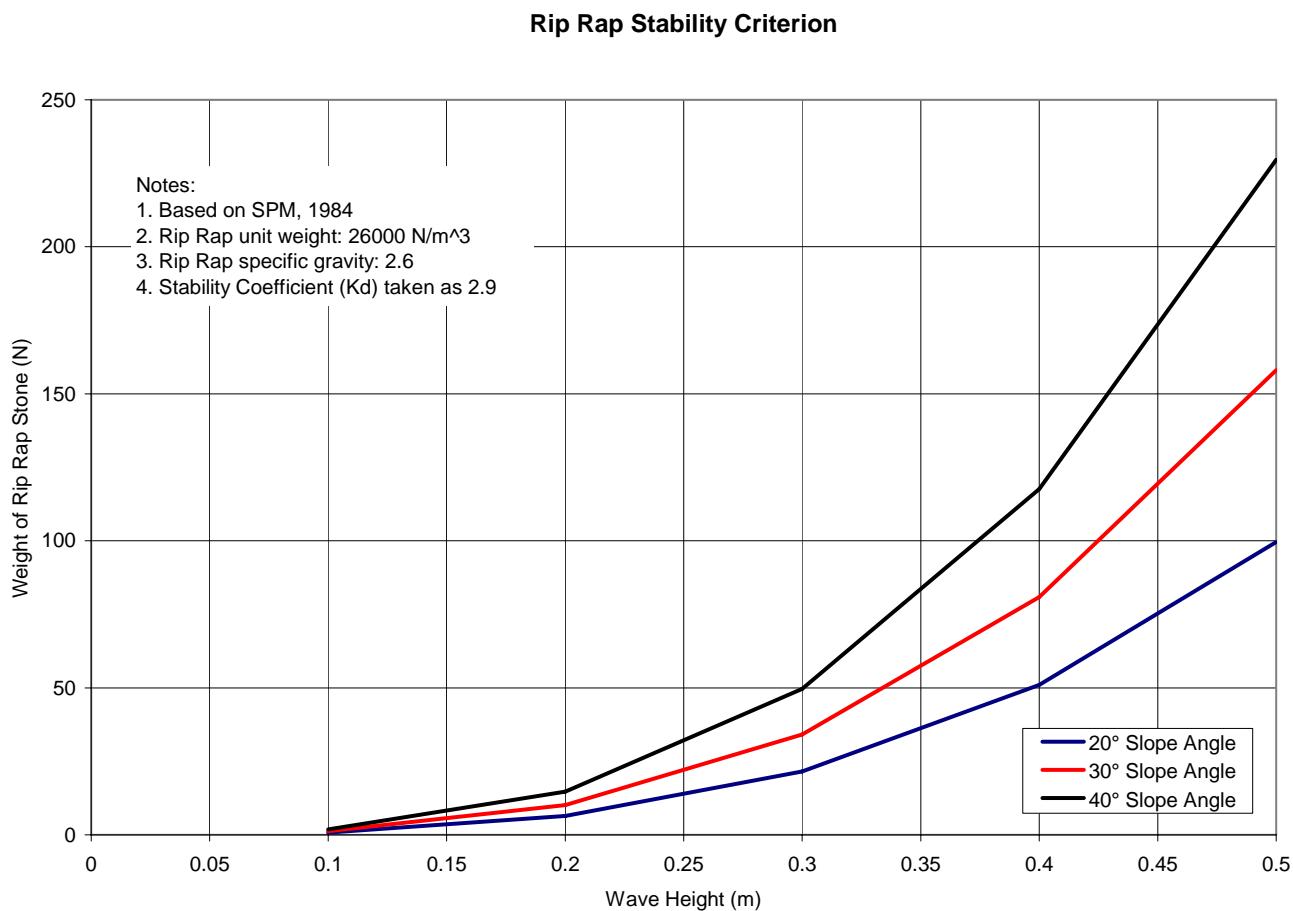
Figure 4.7 Rip-Rap Stability Function (Stanley Island, May 14, 2008)

A rip-rap stability analysis was completed during the **2007/2008** study season to test the hypothesis that the observed rip-rap stone movements might have been caused by ship-induced waves (see **2007/2008 Annual Report, Volumes I and II**). A well established technique developed by the **US Army Corps of Engineers (USACE, 1984)** was used for the analysis and, when coupled with local site parameters generated a set of rip-rap stability criteria (see **Figure 4.7**). The results indicated that the hypothesis was a reasonable explanation as stones of the general size used for the monitoring program could indeed shift under the observed ship-induced wave action.

Recognizing that icebreaking operations were not carried out in the spring of **2009** because a natural ice cover breakup occurred, the rip-rap stone movements observed in **2008/2009** may be considered to represent a baseline condition. It is believed that the observed rip-rap movements were most likely caused by ship-induced wave action rather than ice-related processes.

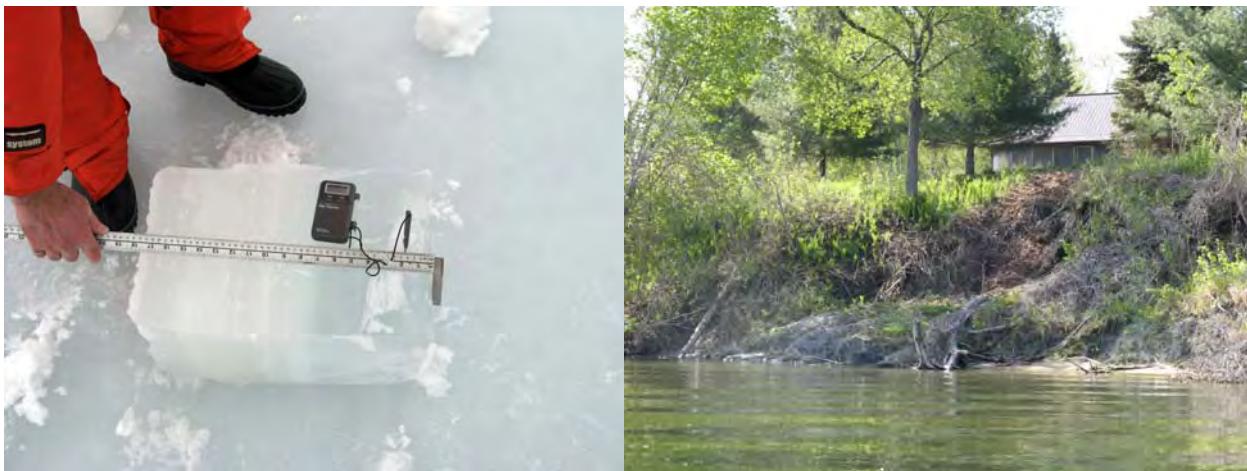
Figure 4.8 Photographic Surveys

The main objective of this type of survey was to visually document significant ice-induced changes of the shoreline. It should be noted that photographs were also taken during practically all surveys as a means to visually record the given activity. As examples, **Figure 4.8** shows a photograph taken while measuring ice thickness (left photo) and also a typical shoreline photograph visually documenting the state of the shoreline at a site that was visited in the fall and spring of **2007/2008**.

During the second observation season, the shoreline photographic surveys were limited to recording only key sites while a more extensive photographic survey was conducted in **2008/2009**. In fact, the entire shoreline under study was photographed in the fall of **2008** using both video and still photography. This was accomplished using a boat as a vantage point. The shoreline was again inspected in the following spring for visible changes or evidence of ice-induced shoreline damage, such as berms, ridges or scars. As in the previous year, the survey did not observe any significant changes to the shoreline.

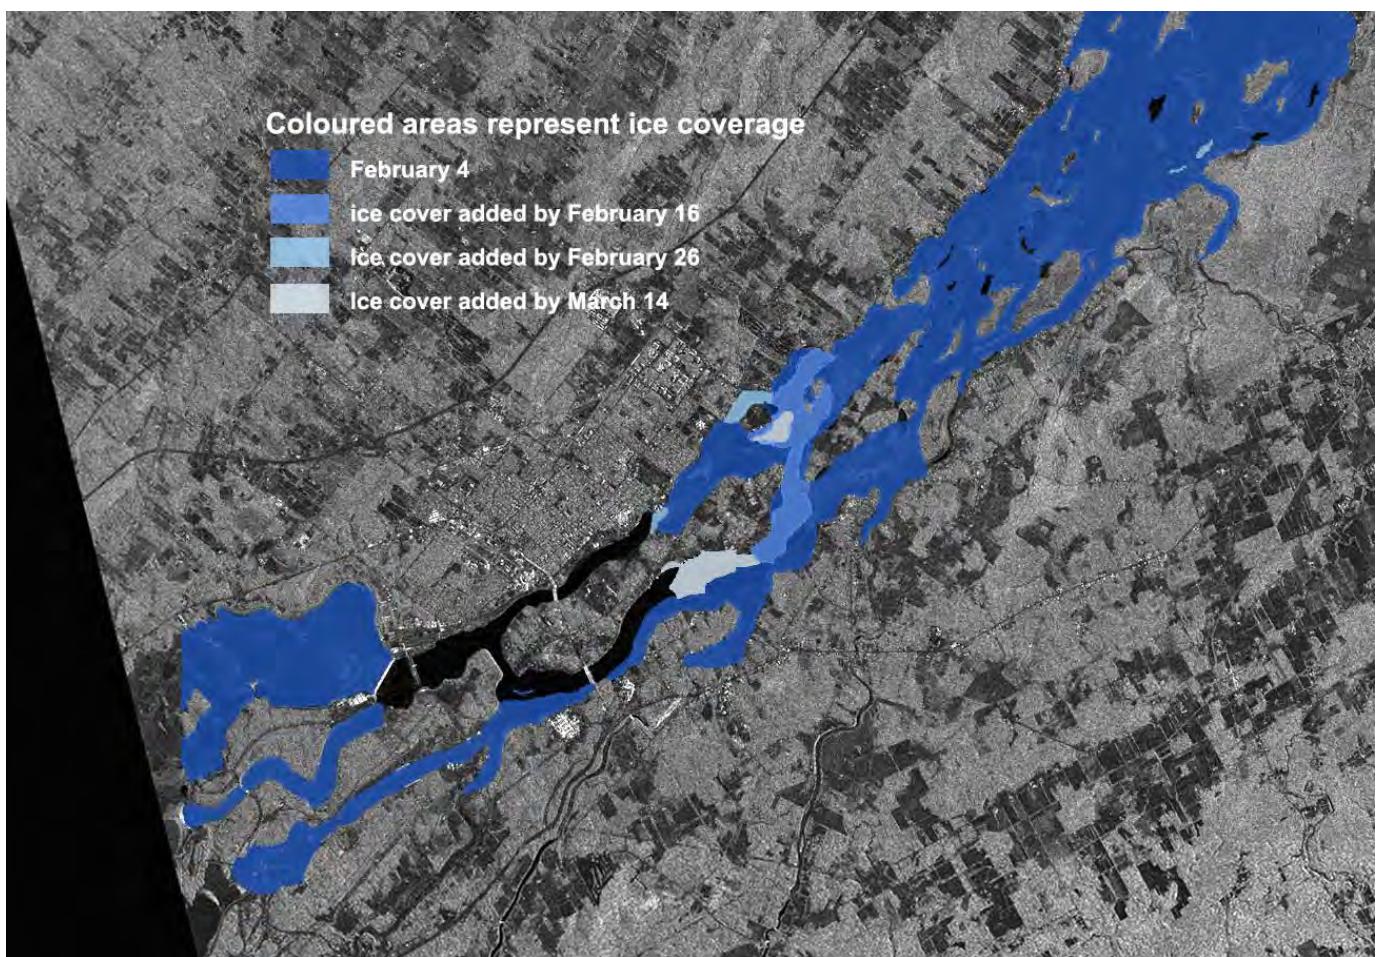
Figure 5.1 RADARSAT Interpreted Growth of Ice Cover (2008)

Satellite-based observations offer substantial advantages for monitoring changes over large areas and in particular, **RADARSAT** satellite imagery data, as shown in **Figure 5.1**, is well suited for observing the state and evolution of the ice cover. Fortunately, access to **RADARSAT** satellite imagery data was secured for the study from the **Canadian Ice Service** for the last two (2) observation seasons.

As anticipated, the imagery data provided significant insight on the growth of the ice cover, the location of the ice edge and the presence of any ridges or major cracks. The spatial distribution of the different types of ice structures was also delineated and

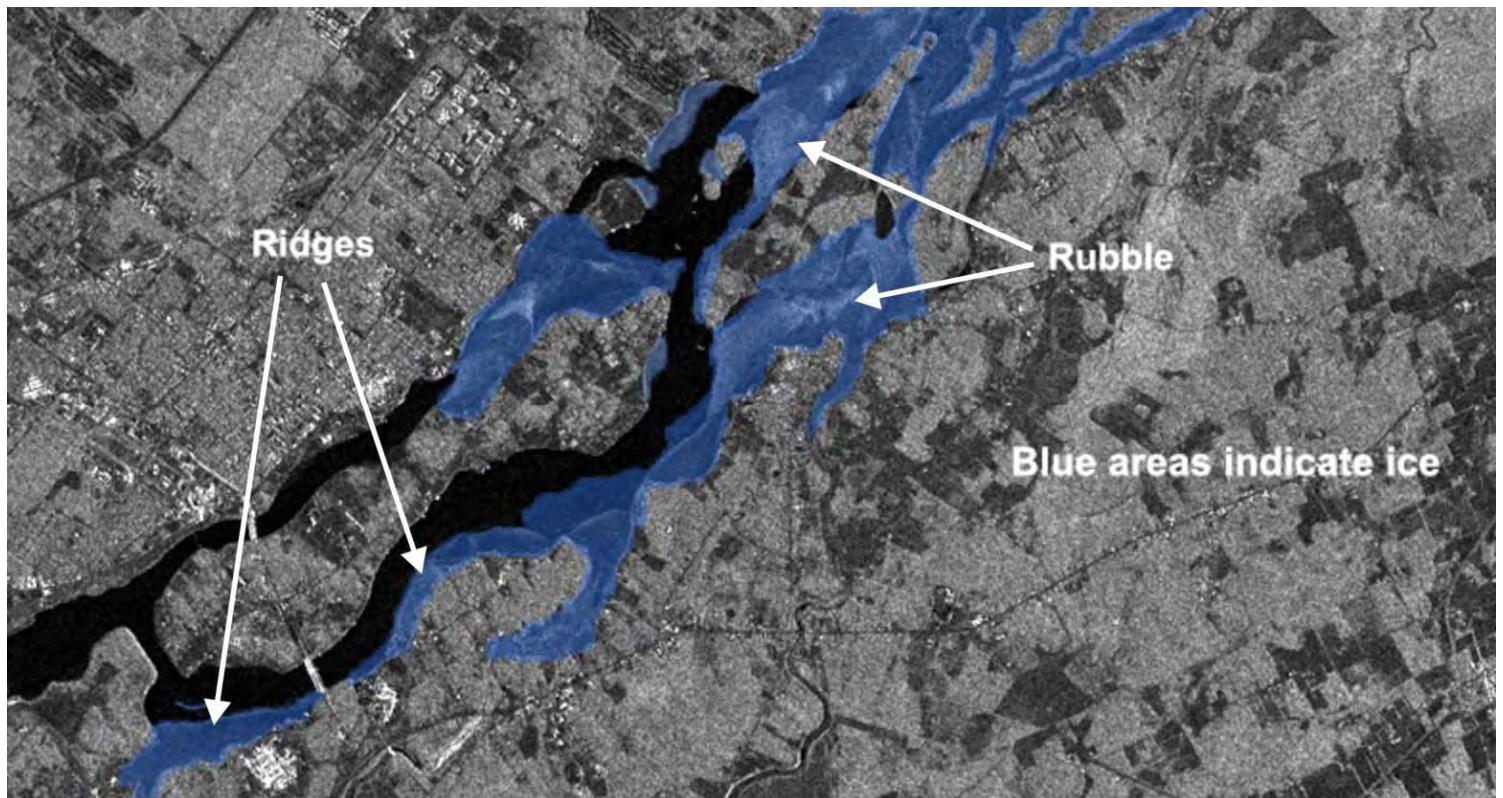
Figure 5.2 RADARSAT Interpreted Ice Features (February 2, 2008)

corroborated by aerial and land-based visual observations. Four (4) separate satellite images covering the study area were generated and analyzed during both the **2007/2008** and **2008/2009** seasons. As previously mentioned, the satellite imagery was particularly useful in mapping the evolution of the ice cover during the winter as shown on **Figure 5.1**. The figure highlights the progressive growth of the ice cover during the winter of **2008** with overlays of several interpreted results obtained by satellite images taken at different times during the winter. Each shade of blue represents the location of the ice cover at a specific time. Aerial fly-bys and ground surveys were used as an aid to interpret the satellite imagery by providing visual confirmation of the observable features as shown in **Figure 5.2**.

Figure 5.2 shows the full extent of the ice cover on **February 2, 2008** as a transparent blue overlay over the **RADARSAT** image. As can be observed, ice cover structures such as ice rubble fields (areas of broken and haphazardly piled blocks of ice) are clearly identifiable. Mapping the location of these particular features is useful for ice clearing operations since these areas are typically more difficult to clear.

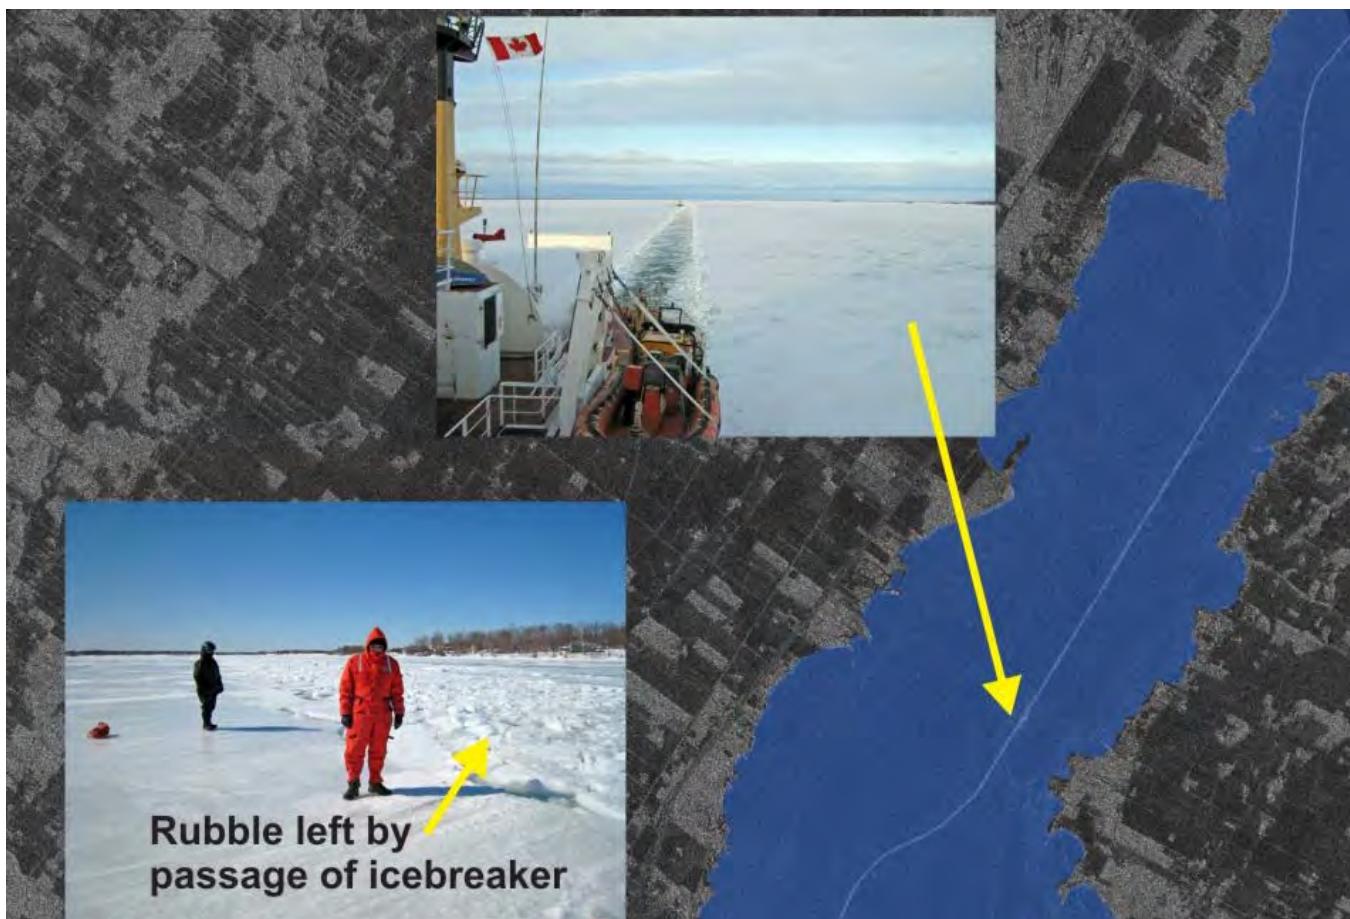
Figure 5.3 RADARSAT – Path of Ice Breaker (March 21, 2008)

The actual path of the ice-breaker can also be mapped by the high resolution satellite data as shown in **Figure 5.3**. The figure shows the particularly clean and incised path in the ice cover created by the ice breaker that was corroborated from two vantage points (insets).

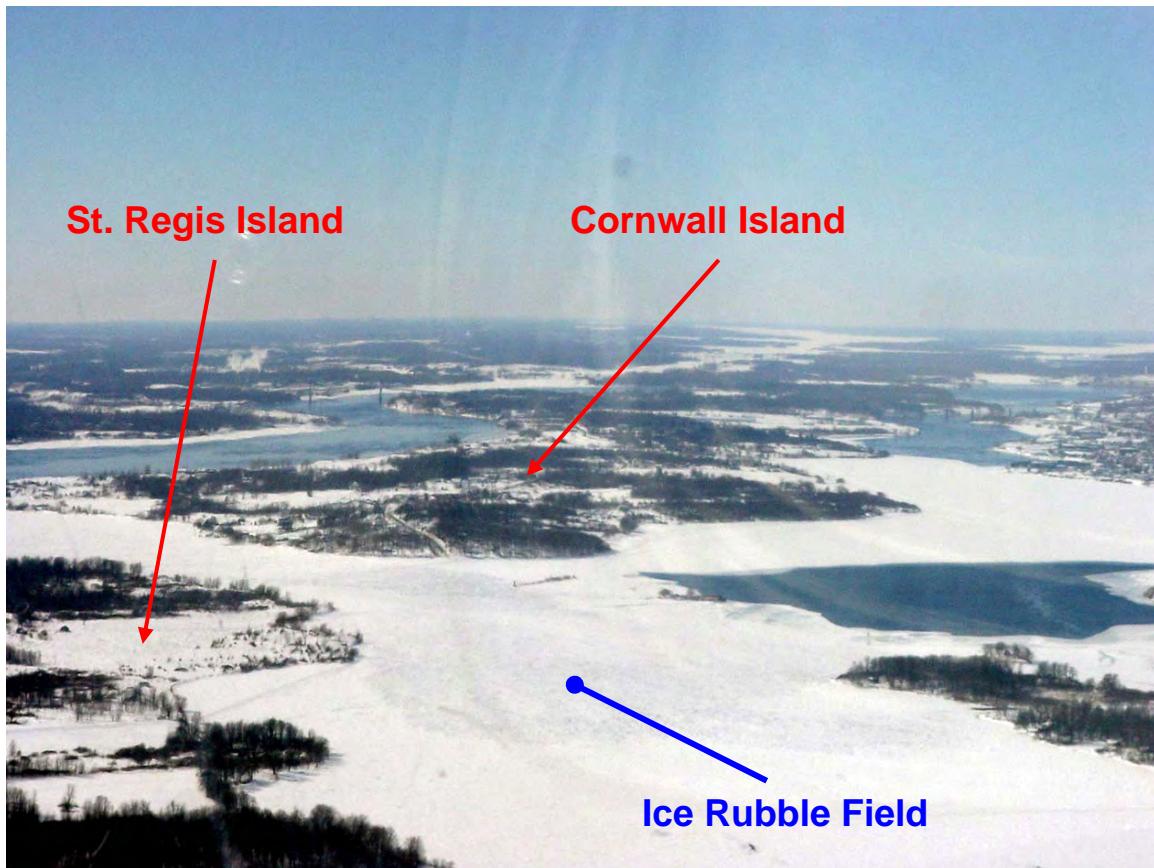
Figure 5.4 Aerial Photograph (February 16, 2008)

Fixed wing and helicopter surveys were also completed throughout the study in an effort to further track the evolution of the ice cover as well as to identify key ice features. The aerial surveys were “piggy-backed” on flights normally completed by the **Canadian Coast Guard** in support of ice clearing operations on the **Seaway**. Photographs and notes were taken during these flights over the navigation channel (see **Figure 5.4**). Seven (7) flights with fixed-wing aircraft plus two (2) helicopter reconnaissance missions were completed during the three (3) year study mandate. **Figure 5.4** shows typical information retrieved from aerial photographs; in this case, the location and extent of the ice rubble field lying immediately downstream of **Cornwall Island**.

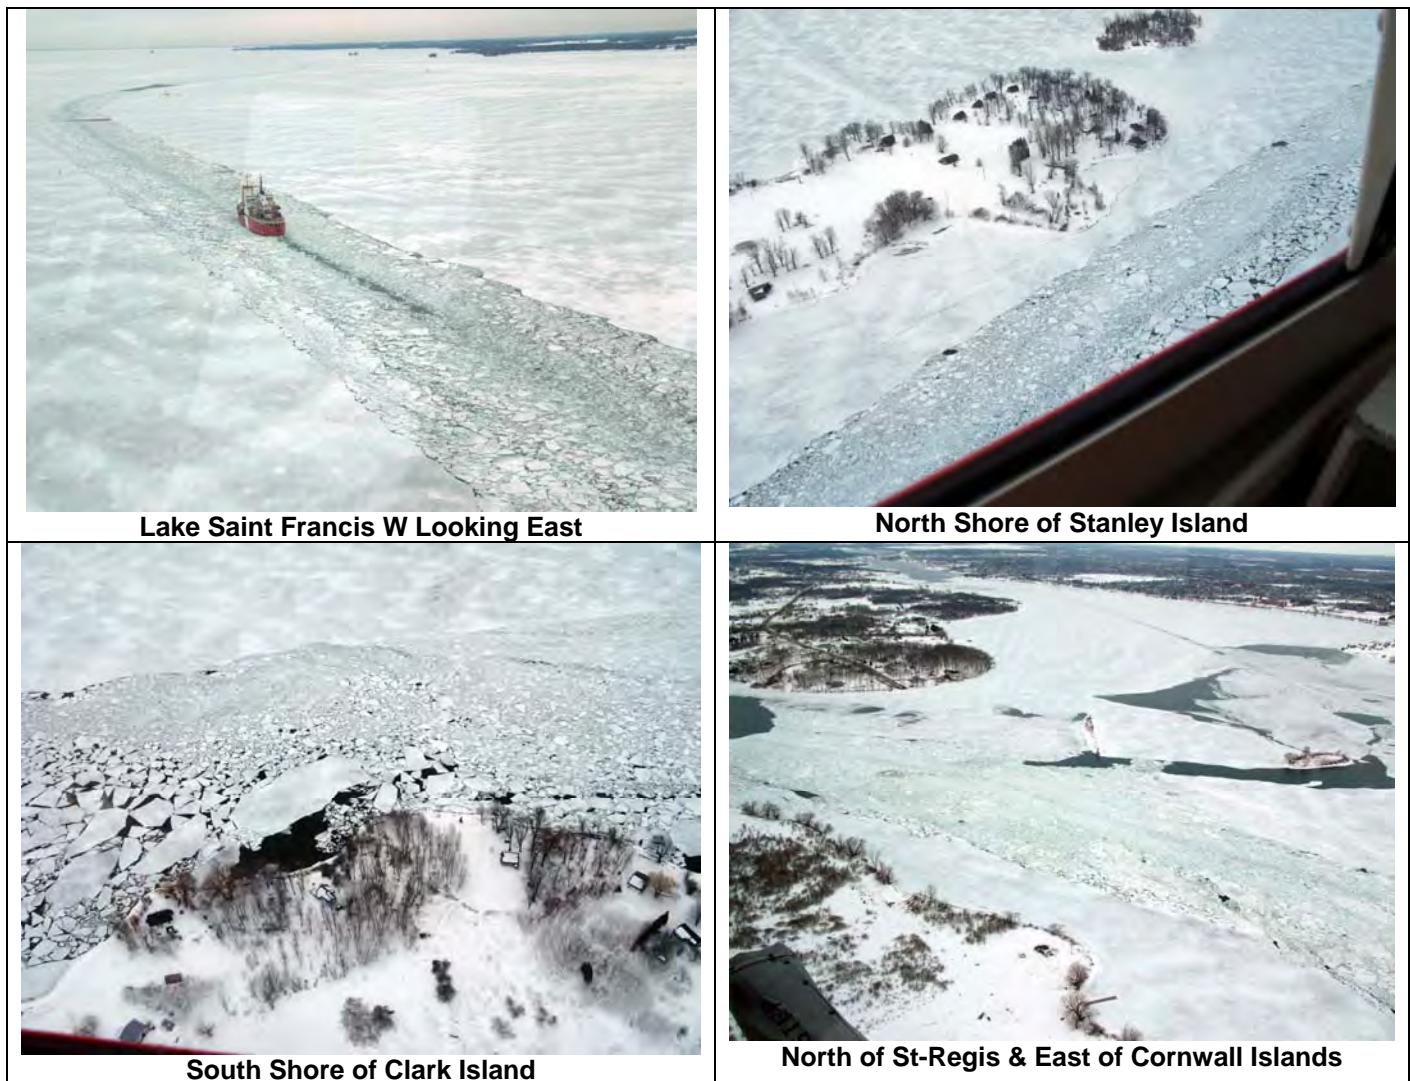
Figure 5.5 Aerial Photograph of Post-Cleared Channel (March 28, 2008)

One (1) of the aerial flight surveys in **2008** was completed one (1) week after the initial ice clearing operations on **March 20, 2009**. Shore-based and on-ice observations were also conducted during this period to complement the aerial finding of a post-cleared navigation channel. **Figure 5.5** shows that broken ice is constrained to the cleared channel and generally still attached to the shoreline, except at **Clark Island**. No signs of significant ice-induced post-clearing shoreline impacts were observed by these surveys.

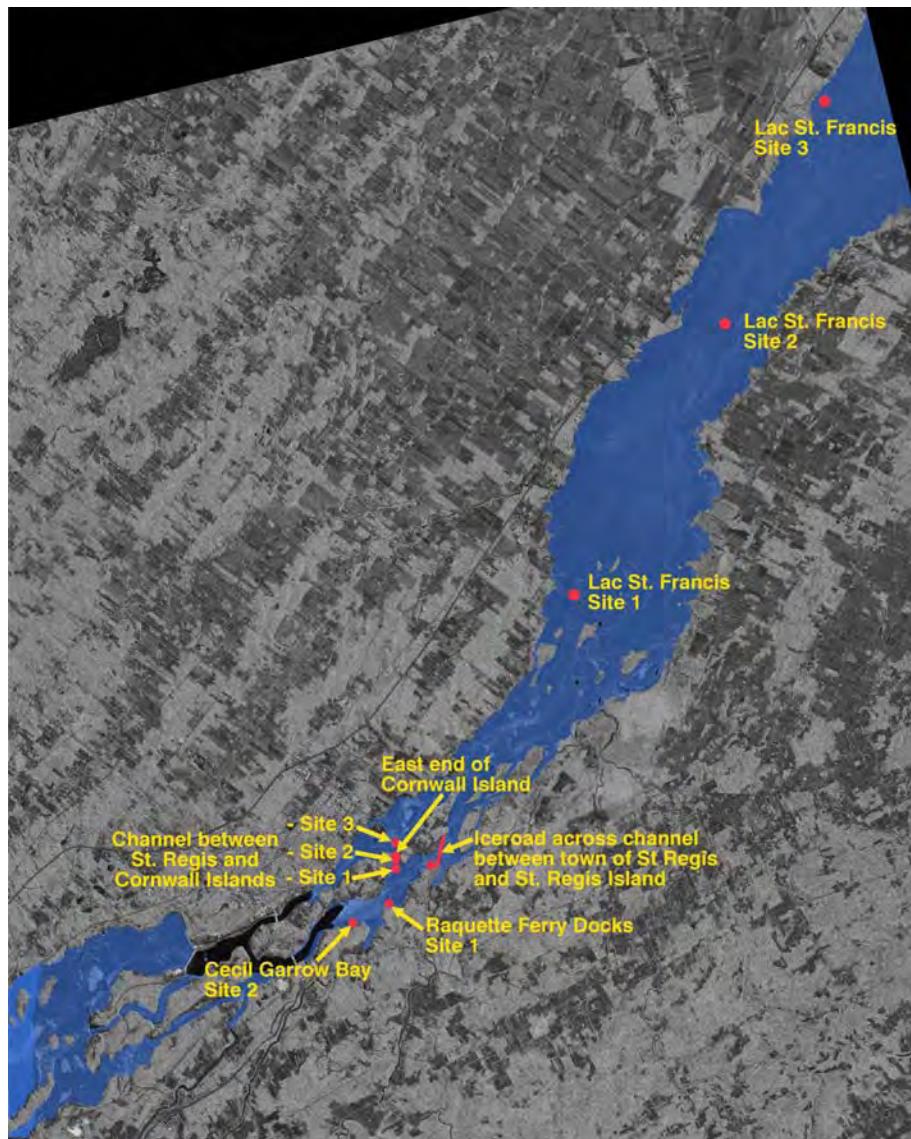
Figure 5.6 On-Ice Survey Locations (Winter/Spring 2008)

Several on-ice surveys were completed during the last two winter/spring seasons in order to characterize the ice's strength and structure during the winter and leading up to the ice clearing operations. Ice thickness and temperature profile measurements were taken at several sites during each of the two (2) seasons (see **Figure 5.6**).

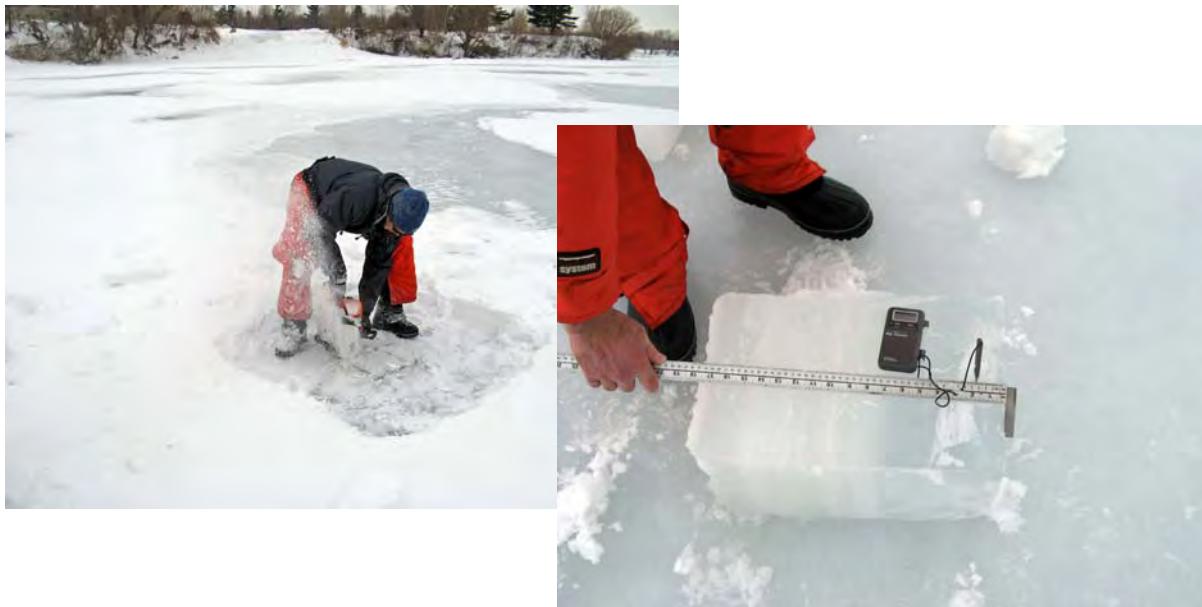
Figure 5.7 On-Ice Surveys (Winter/Spring 2008)

Photographs and notes were also taken to document the methodology, the observed ice structure and the local environmental conditions (see **Figure 5.7**).

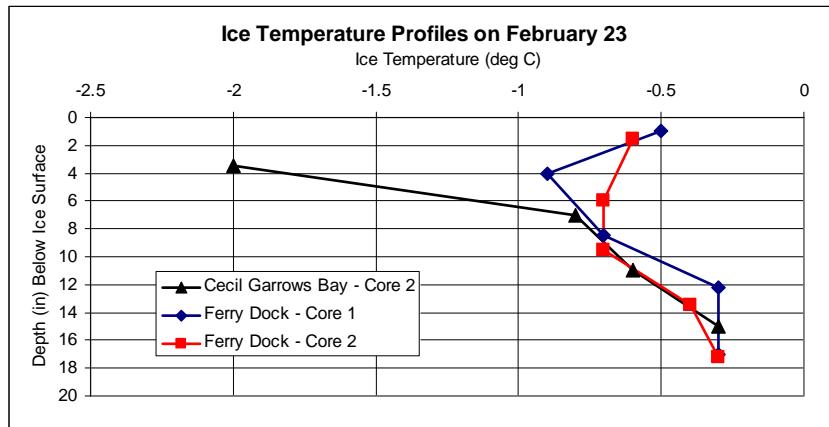
Figure 5.8 On-Ice Surveys (Winter/Spring 2008)

The field data was compiled and analyzed in combination with other information such as the accumulated **Freezing Degree Days** to generate a better understanding of the winter ice cover regime. **Figure 5.8** shows a typical data compilation, in this case, a graph of the ice temperature profiles taken at three (3) locations on **February 23, 2008**.

As expected, the ice temperature generally increased over the winter. As well, the ice temperature varied with depth in the ice, which also follows the expected trend. The maximum ice thickness that was measured during both observation seasons at the monitoring sites was approximately 52 cm in late winter while the minimum ice temperature recorded was -1.7° C in **2008** and -2.0° C in **2009**. However, the mean ice temperature increased to nearly zero degrees, indicating a reduced strength, during the last winter survey of **2008** (which took place a few weeks prior to the ice clearing operations).

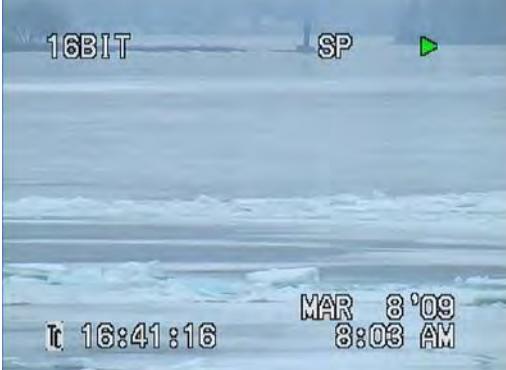
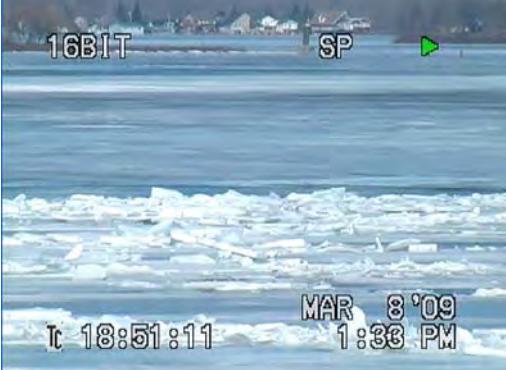
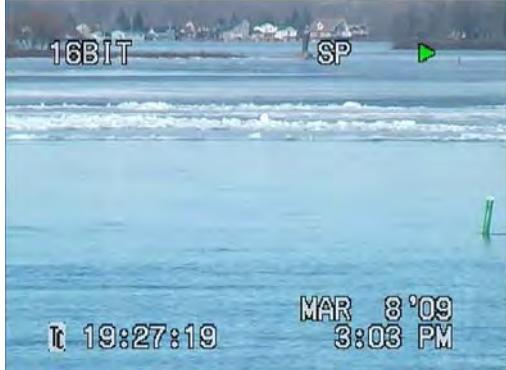
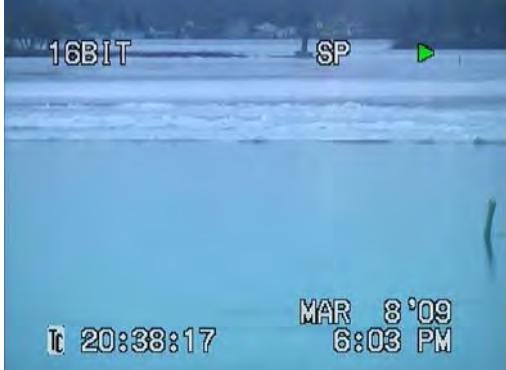
Figure 5.9 Natural Ice Cover Break up (March 2009)

No visual data on ship transits were obtained in **2009** due to the natural breakup of the ice cover that occurred more than three (3) weeks prior to the **Seaway Opening Date**. Nevertheless, the initial ice cover breakup that started on **March 8, 2009** was fully recorded on video as can be seen in **Figure 5.9**. In fact, ice deterioration was first observed on **March 7** from the video camera records when a small patch of open water appeared around the navigation buoy in the camera's field of view. Shortly after, the ice cover in the channel between **St. Regis** and **Cornwall Islands** broke up

rapidly, over the course of the following day (see video sequence in **Figure 5.8**). Photos taken during a site visit on **March 17, 2009** showed that most of the navigation channel within the study area was ice-free.

<p>16BIT SP ▶ MAR 8 '09 1:33 PM T 18:51:11</p>
08:03 March 8: Initial Rubbled Ice in Foreground	13:33 March 8: Increased Rubbled Ice in Foreground

<p>16BIT SP ▶ MAR 8 '09 6:03 PM T 20:38:17</p>
15:03 March 8: Extensive Open Water – Open Water from Foreground to Ice Edge	18:03 March 8: Extensive Open Water – Open Water from Foreground to Ice Edge

The analyses of the water elevation and flow data at the **Moses Saunders Dam** during the last two (2) springs of the study yielded important insight into the factors affecting ice cover conditions. For example, it was noted that flows were less than the 30-year average during most of the **2007/2008** winter although closer to the long-term average in the period leading up to the ice clearing operations. A mostly intact ice cover condition prevailed under these flows during the late winter of 2008 and during the ice clearing operations. In contrast, flows during the early winter of **2009** were near the long-term average; however, a sharp increase in flows (i.e., about 300 cms higher) occurred during the month of **March 2009**. This rapid increase in flows likely played a key role in the early ice cover breakup in 2009, by de-stabilizing the ice cover and breaking it away from the shoreline. The higher flows that prevailed at the time and throughout the **2008/2009** winter would also have facilitated “flushing” of the ice downstream as was documented by the onshore video camera (**Figure 5.9**).

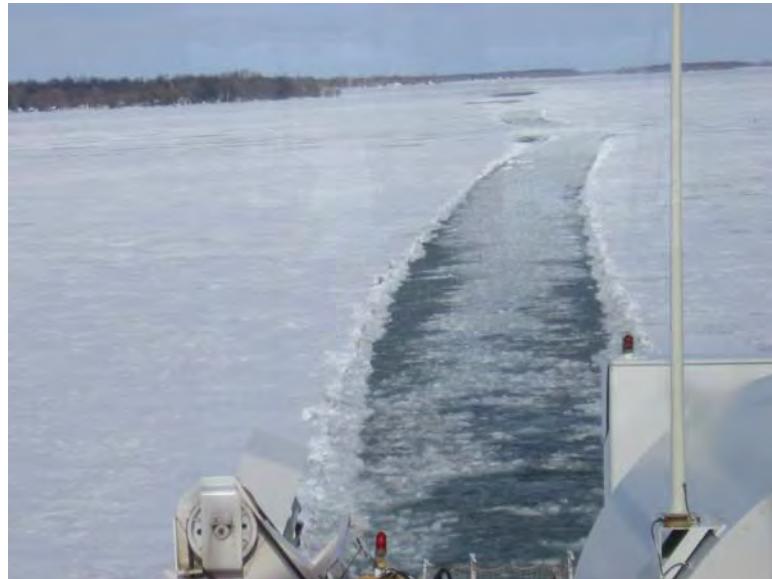
Figure 5.10 Ice Clearing (March 2007)

significant observations were made during these first two (2) seasons. Photographs were the primary means of documenting the ice clearing operations by the study team aboard the **CCGS Martha L. Black** in 2007 (**Figure 5.10**) and again in 2008 (**Figure 5.11**).

- The ice breaker's speed was reduced upon approaching the eastern boundary of the **Akwesasne** islands;
- The width of the broken track left behind the **CCGS Martha L. Black** was close to the ship's beam as shown in **Figure 5.10** and **Figure 5.11**;

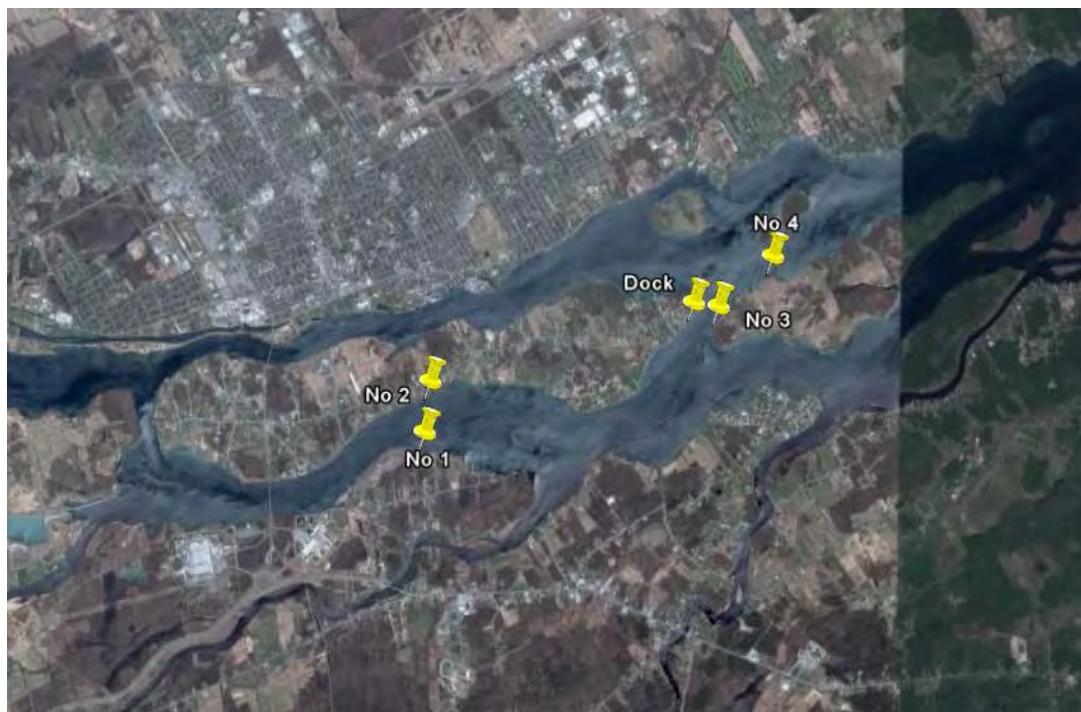
Figure 5.12 Shoreline-Based Ice Movement Monitoring Sites (2008)

Shoreline-based observations and ice movement measurements were only made in the spring of **2008** although this activity was planned for **2009**. It was not done during spring **2009** because a natural ice breakup occurred. The general objective of this task was to observe any changes in the ice conditions and to quantify any ice movement near the shore during the passage of the ice breaker - Ice movements are a necessary component of any significant shoreline impacts. Note that an attempt was made in the spring of **2007** to also measure the movement of ice by marking the ice surface with soluble die. Unfortunately, heavy rainfalls diluted the die and consequently, none was visible during aerial and field surveys immediately following the ice clearing operations. **Figure 5.12** shows the five (5) sites that were originally targeted for ice movement monitoring in the spring of **2008**.

Sites #1 and **#2** were eventually eliminated because the ice cover had not formed in that section of the river. Observations at the **Dock** site were also impossible due to access issues (previously discussed). Nevertheless, the remaining two (2) sites (**Site #3** & **Site #4**) were successfully instrumented on the day before the ship's passage and then re-surveyed early the next day. Unfortunately, direct visual observations were not possible during the actual ship's passage because the **CCGS Martha L. Black** arrived under the cover of darkness on the evening of **March 20, 2008**.

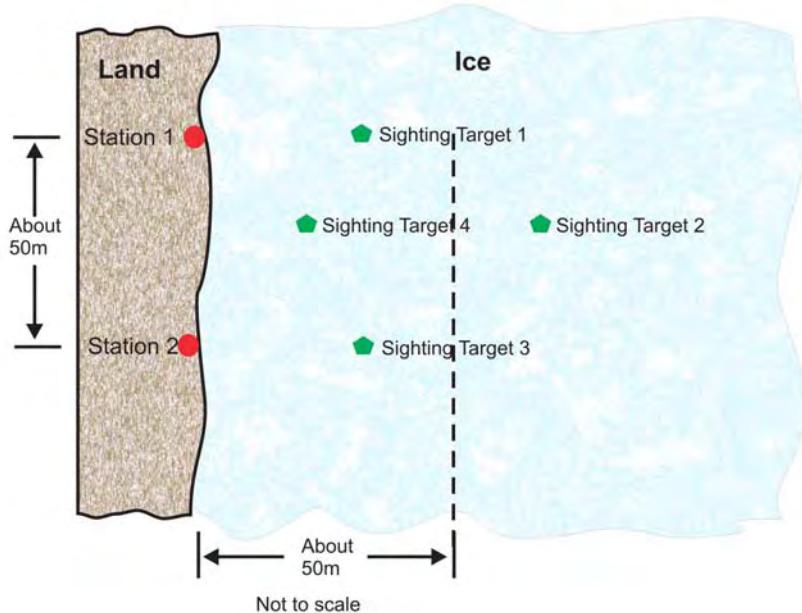
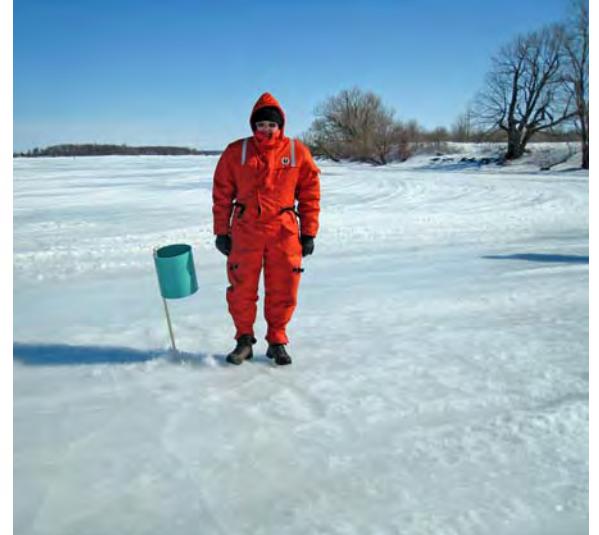
Figure 5.13 Shoreline-Based Ice Movement Instrumentation (2008)

Figure 5.13 shows the planned deployment pattern and a sample of the ice movement targets. The locations of the targets were determined prior to the ship's passage by measuring the distances to them from two shoreline stations, which were used to establish a reference baseline. Distances were subsequently measured using laser rangefinders. As previously mentioned, both sites were re-visited on the morning after the ice breaker had passed through, and the ice movement targets were re-surveyed. Also, the ice conditions at each site were observed and photographed.

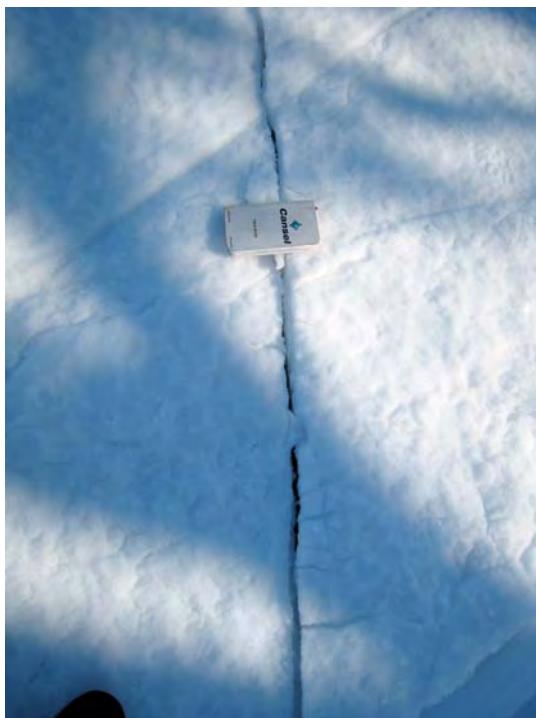
Figure 5.14 Ice Crack Running Parallel to Shore (March 2008)

Only one significant crack was observed, which ran parallel to shore (**Figure 5.14**). No ice displacements were observed on either side of the crack. This crack was uniform alongshore, and ran parallel to the shore for a long distance (as far as could be seen). This indicates that it was most likely produced by changes in water level.
