Final Study Report

JOINT OBSERVATIONAL STUDY (JOS)

Seaway Shoreline Icebreaking Impacts Between Snell Lock & Lake St-Francis

August 2009 – Final Version

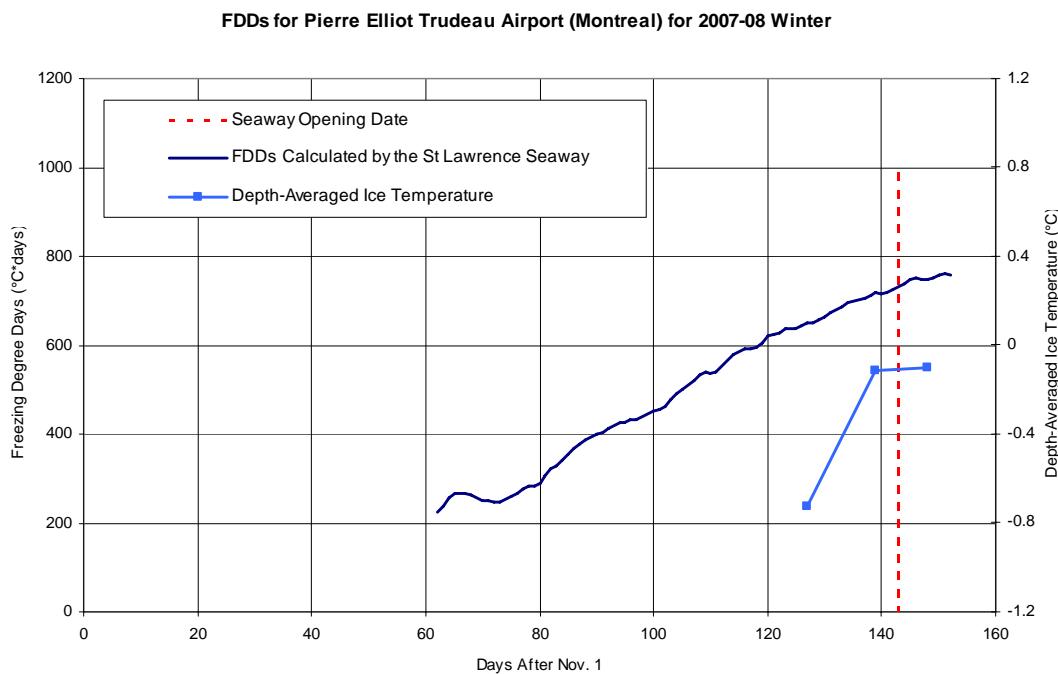
Figure 5.15 Freezing Degree Days (2007/2008 Annual Report)

The **JOS** study team began using this model in a similar capacity in **2007**; however, significant limitations were identified in **2008** and **2009** in using the **FDDs** as a single indicator of ice conditions. Extensive analyses indicated that other factors, such as fluctuations in water levels and flows, also have significant impacts on ice conditions. The analyses revealed that by applying the **FDD** method, the results erroneously indicated a more severe **2008/2009** winter/spring than was observed in **2007/2008**, as there were more **FDDs** in **2008/2009** as compared to **2007/2008** (i.e., maxima of 895 and 760 °C*days, respectively).

Considering that a natural ice cover breakup occurred in **2008/2009** at a much earlier date than the icebreaker-induced breakup in **2007/2008**, it was concluded, as previously mentioned, that other factors such as water levels and flows and the temporal variations of weather throughout the winter are equally important in characterizing the state of the ice cover; hence, the FDD method should not be used exclusively as a gauge of the ice conditions.

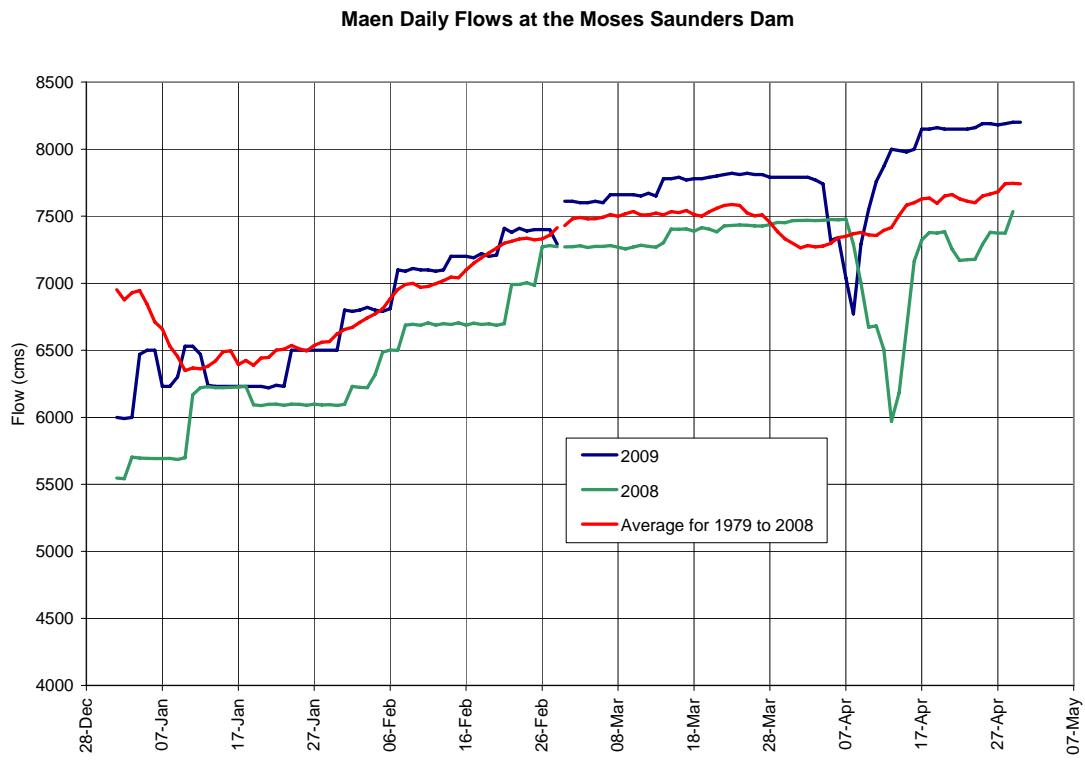
Figure 5.16 Mean Daily Flows – Moses-Saunders Dam (2008/2009)

Water level elevations and flow data for the tailrace of **Ontario Power Generation's (OPG) Moses-Saunders Generating Station**, (which is located immediately upstream of the study area), as well as water level elevation data for the **Cornwall Harbor**, as provided by **Environment Canada** were used for the analyses. Both historical records and data for the study period were acquired for analysis. **Figure 5.16** shows the mean daily variations in flows at the **Moses-Saunders Dam** for the spring of **2009**.

The analyses of the water elevation and flow data at the **Moses Saunders Dam** during the last two (2) springs of the study yielded important insight into the factors affecting ice cover conditions. For example, it was noted that flows were less than the 30-year average during most of the **2007/2008** winter although closer to the long-term average in the period leading up to the ice clearing operations. A mostly intact ice cover condition prevailed under these flows during the late winter of 2008 and during the ice clearing operations. In contrast, flows during the early winter of **2009** were near the long-term average; however, a sharp increase in flows (i.e., about 300 cms higher) occurred during the month of **March 2009**. This rapid increase in flows likely played a key role in the early ice cover breakup in 2009, by de-stabilizing the ice cover and breaking it away from the shoreline. The higher flows that prevailed at the time and throughout the **2008/2009** winter would also have facilitated “flushing” of the ice downstream as was documented by the onshore video camera (**Figure 5.9**).
